**Flood Control Project Maintenance  
Levee Inspections**

## Maintenance Issue Types Only, Levee Inspection Report By Mile - Spring 2018

### Plumas County

Waterway	Bank	Unit Miles	Inspection Start/End	Inspector
Unit No. 01 North Fork Feather River	Left	1.89	04/26/2018 04/26/2018	Bob Duffey

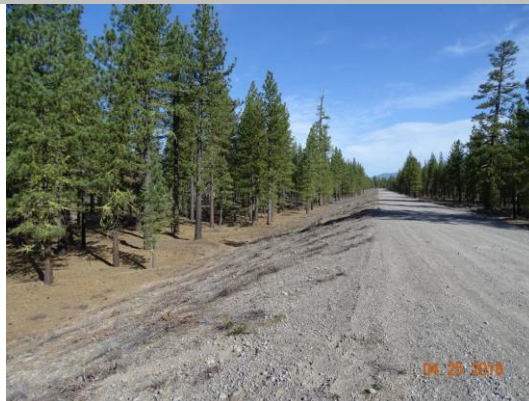
Photo 1 of 2 : SP\_2018\_NA0015\_337\_12\_20180501\_00019.jpg

LM Start	0.00	Rating **	A	Issue No.	12
LM End	0.78	Issue Type +	Ma	Location *	WS
Category	Earthen Levee			GPS Latitude/Longitude	
				Start	End
Item	Vegetation			40.273168 °	40.282842 °
				-121.244783 °	-121.251338 °
DWR ID	DWR_NA0015_01_f_2015_12				
Comment Code					
V2 : Remove the wild growth other than native grasses from the levee slopes.					
Inspector Comment					
The small pine trees and other vegetation was removed from the levee slope.

View of the removed pine trees and other vegetation from the waterside slope.

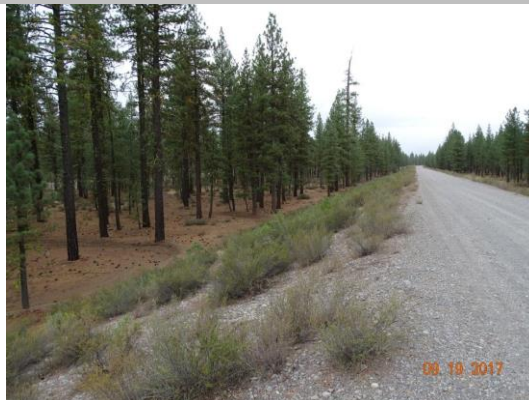
Photo 2 of 2 : SP\_2018\_NA0015\_337\_12\_20180305\_00009.jpg

View of the small pine trees and other vegetation on the waterside slope.

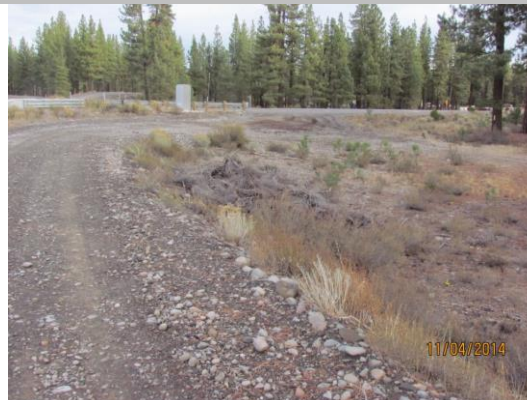
Photo 1 of 1 : SP\_2018\_NA0015\_337\_4\_20180305\_00001.jpg

LM Start	0.68	Rating **	M	Issue No.	4
LM End	0.68	Issue Type +	Ma	Location *	LS
Category	Earthen Levee			GPS Latitude/Longitude	
				Start	End
Item	Encroachments			40.281480 °	40.281480 °
				-121.250928 °	-121.250928 °
DWR ID	DWR_NA0015_01_s _ 2013_4				
Comment Code					
PR : Prunings					
Inspector Comment

View of the prunings along the landside slope.

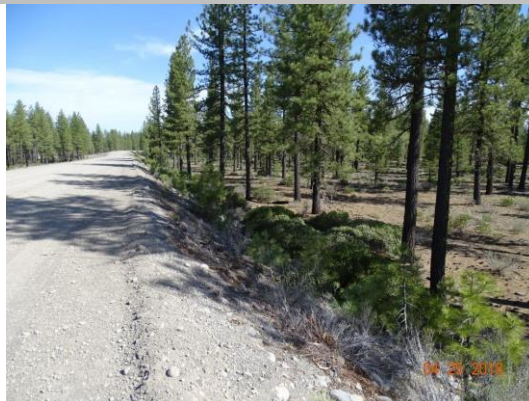
Photo 1 of 1 : SP\_2018\_NA0015\_337\_18\_20180501\_00027.jpg

LM Start	0.79	Rating **	M	Issue No.	18
LM End	1.88	Issue Type +	Ma	Location *	LS
Category	Earthen Levee			GPS Latitude/Longitude	
				Start	End
Item	Vegetation			40.282962 °	40.297068 °
				-121.251307 °	-121.257120 °
DWR ID	DWR_NA0015_01_s_2018_18				
Comment Code					
V2 : Remove the wild growth other than native grasses from the levee slopes.					
Inspector Comment					
Remove the small pine trees and vegetation from the landside slope.

View of the small pine trees and vegetation along the landside slope.

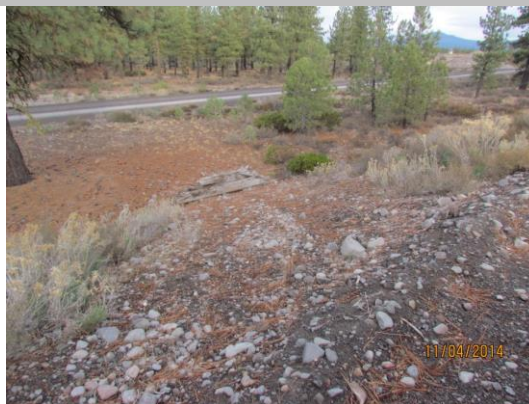
Photo 1 of 1 : SP\_2018\_NA0015\_337\_5\_20180305\_00002.jpg

LM Start	0.96	Rating **	A/W	Issue No.	5
LM End	0.96	Issue Type +	Ma	Location *	WS
Category	Earthen Levee			GPS Latitude/Longitude	
				Start	End
Item	Slope Stability			40.285363 °	40.285363 °
				-121.251973 °	-121.251973 °
DWR ID	DWR_NA0015_01_f_2013_5				
Comment Code					
S3 : Repair the levee slope damaged by vehicle traffic and prevent access where possible.					
Inspector Comment

View of the vehicle erosion along the waterside slope.

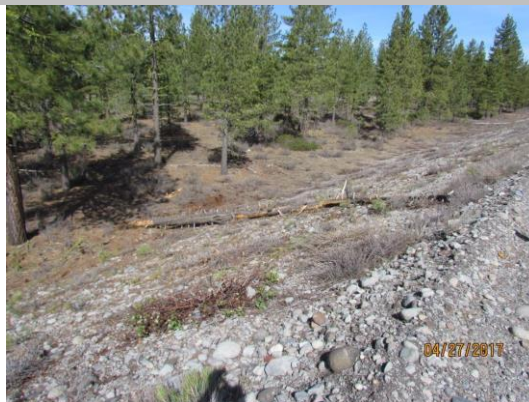
Photo 1 of 1 : SP\_2018\_NA0015\_337\_16\_20180305\_00013.jpg

LM Start	1.17	Rating **	M	Issue No.	16	
LM End	1.17	Issue Type +	Ma	Location *	WS	
Category	Earthen Levee			GPS Latitude/Longitude		
				Start		End
Item	Encroachments			40.287722 °		40.287722 °
				-121.253510 °		-121.253510 °
DWR ID	DWR_NA0015_01_s_2017_16					
Comment Code						
TR : Tree or limb						
Inspector Comment						
Remove the tree from the landside slope and toe.

View of the tree along the landside slope and toe.

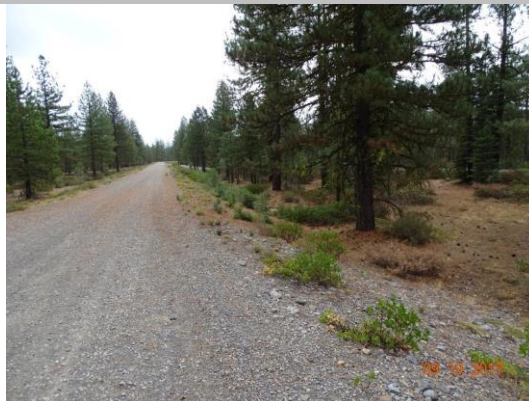
Photo 1 of 1 : SP\_2018\_NA0015\_338\_2\_20180305\_00001.jpg

LM Start	0.00	Rating **	M	Issue No.	2	
LM End	0.71	Issue Type +	Ma	Location *	LS	
Category	Earthen Levee			GPS Latitude/Longitude		
				Start		End
Item	Vegetation			40.286462 °		40.279948 °
				-121.260082 °		-121.252118 °
DWR ID	DWR_NA0015_02_f_2017_2					
Comment Code						
V2 : Remove the wild growth other than native grasses from the levee slopes.						
Inspector Comment						
Remove the small pine trees and vegetation from the landside slope.

View of the small pine trees and vegetation along the landside slope.

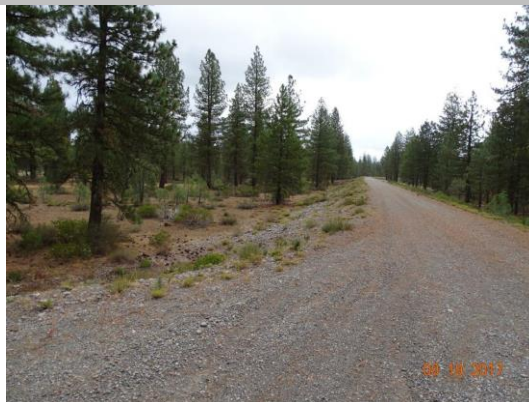
Photo 1 of 1 : SP\_2018\_NA0015\_338\_3\_20180305\_00002.jpg

LM Start	0.00	Rating **	M	Issue No.	3
LM End	0.71	Issue Type +	Ma	Location *	WS
Category	Earthen Levee			GPS Latitude/Longitude	
				Start	End
Item	Vegetation			40.286462 °	40.279948 °
				-121.260082 °	-121.252118 °
DWR ID	DWR_NA0015_02_f_2017_3				
Comment Code					
V2 : Remove the wild growth other than native grasses from the levee slopes.					
Inspector Comment					
Remove the small pine trees and vegetation from the waterside slope.

View other small pine trees and vegetation along the waterside slope.

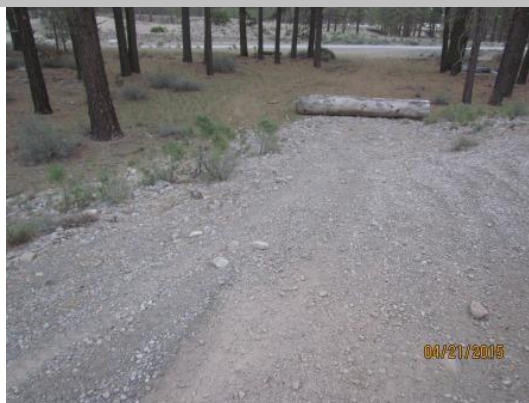
Photo 2 of 2 : SP\_2018\_NA0015\_338\_6\_20180305\_00006.jpg

View of the vehicle erosion on the waterside slope.

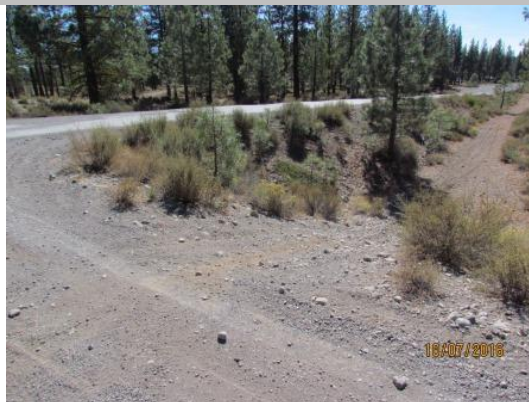
Photo 1 of 1 : SP\_2018\_NA0015\_338\_4\_20180305\_00003.jpg

LM Start	0.55	Rating **	M	Issue No.	4
LM End	0.55	Issue Type +	Ma	Location *	LS
Category	Earthen Levee			GPS Latitude/Longitude	
				Start	End
Item	Slope Stability			40.281950 °	121.253710 °
				40.281950 °	121.253710 °
DWR ID	DWR_NA0015_02_s_2012_4				
Comment Code					
S3 : Repair the levee slope damaged by vehicle traffic and prevent access where possible.					
Inspector Comment

View of the slope instability cause by vehicle along the landside slope.

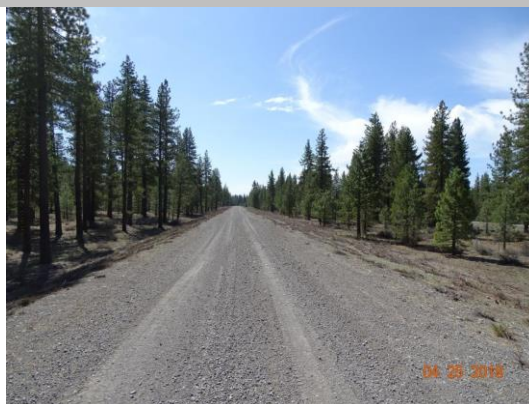
Photo 1 of 1 : SP\_2018\_NA0015\_338\_7\_20180501\_00013.jpg

LM Start	0.71	Rating **	A	Issue No.	7
LM End	1.36	Issue Type +	Ma	Location *	LS
Category	Earthen Levee			GPS Latitude/Longitude	
				Start	End
Item	Vegetation			40.279948 °	40.271748 °
				-121.252118 °	-121.246737 °
DWR ID	DWR_NA0015_02_s _ 2018_7				
Comment Code					
V2 : Remove the wild growth other than native grasses from the levee slopes.					
Inspector Comment					
Small pine trees was removed from the landside slope.

View of the removed small pine trees from the landside slope.
